Using thermal imaging to troubleshoot motors and drives

By Sat Sandhu

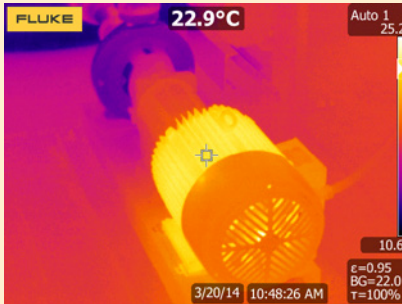
Combo: This heat pattern indicates an operational motor.
